WEAR CHARACTERISTICS OF SPUTTERED VS. ELECTROPLATED CHROMIUM ON ALUMINUM

ANDREW CROWSON

January 1977

GENERAL THOMAS J. RODMAN LABORATORY
ROCK ISLAND ARSENAL
ROCK ISLAND, ILLINOIS 61201

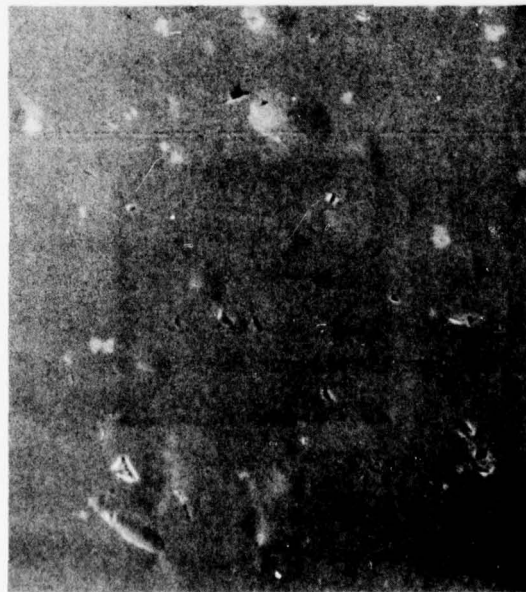
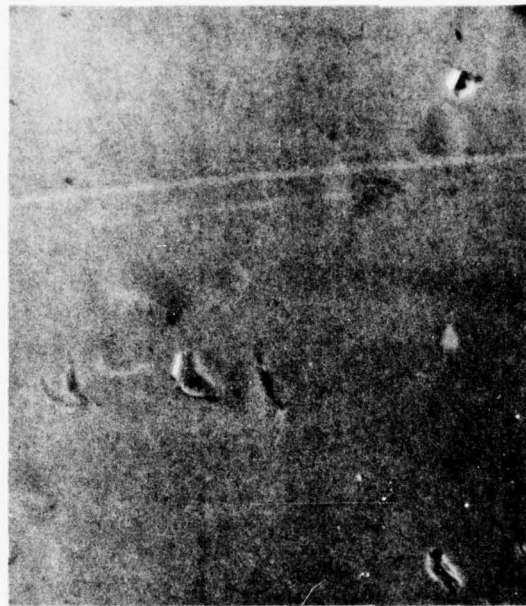
FIGURE 5

Surface of Sputtered Chromium Deposits

SEM photomicrographs of the electroplated and sputtered chromium surfaces are shown in Figures 4 and 5. The chromium surface shown in Figure 4 has the characteristic dome-like projections prevalent for electroplated deposits. An inherent network of cracks is exhibited in the deposit. The pattern consists of crack-free areas ("plateaus") with fine grains. The basic cause of the cracks in the deposit was shown by Snively to be related to the formation of unstable chromium hydrides of variable composition during the plating operation.⁹ Figure 5 shows the characteristic surface of a typical sputtered chromium deposit. Unlike the uneven-crack surface of the electroplated deposits, a relatively smooth, powdery surface is exhibited by the sputtered deposits. Small crater-like defects are noticeable throughout the surface. The presence of particulates or perturbations on the substrate surface can cause the formation of such defects. Careful cleaning and handling of the substrates and target materials before sputtering deposition, however, help to minimize the number of these structural defects.¹⁰

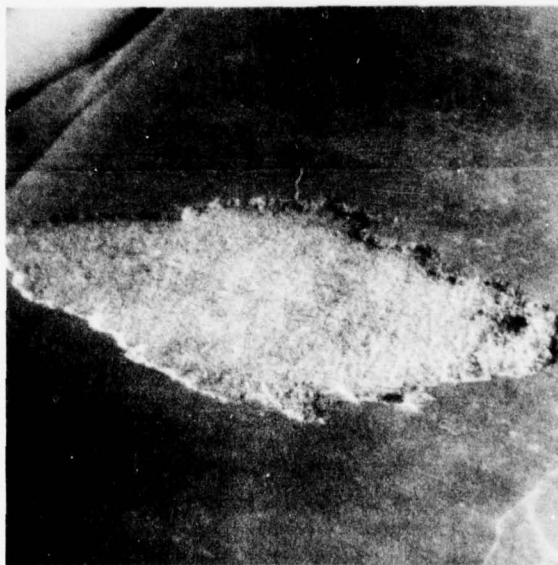
FIGURE 8 Electroplated Chromium Flaking Observed During Wear

Explanation of the differences noted in the wear rates between electroplated and sputtered chromium deposits can be best understood after examination of the wear surfaces. In Figure 7, typical wear scars formed on electroplated and sputtered chromium deposits are shown. The sputtered chromium wore evenly throughout the wear cycle, i.e., layer by layer, whereas the electroplated chromium was susceptible to catastrophic failure by shearing and flaking. Closer examination of a typical section in the electroplated deposit where flaking occurred, reveals underlying, exposed aluminum (see Figure 8). SEM micrographs of a tapered section through the wear cross section are shown in Figure 9. Again, shearing and flaking of chromium plates are evident during the wear process.
